REPORT#: 19KY033

Commercial Truck Driver Dies on Kentucky Interstate in Single Vehicle Collision

Fatality Assessment and Control Evaluation (FACE) Program

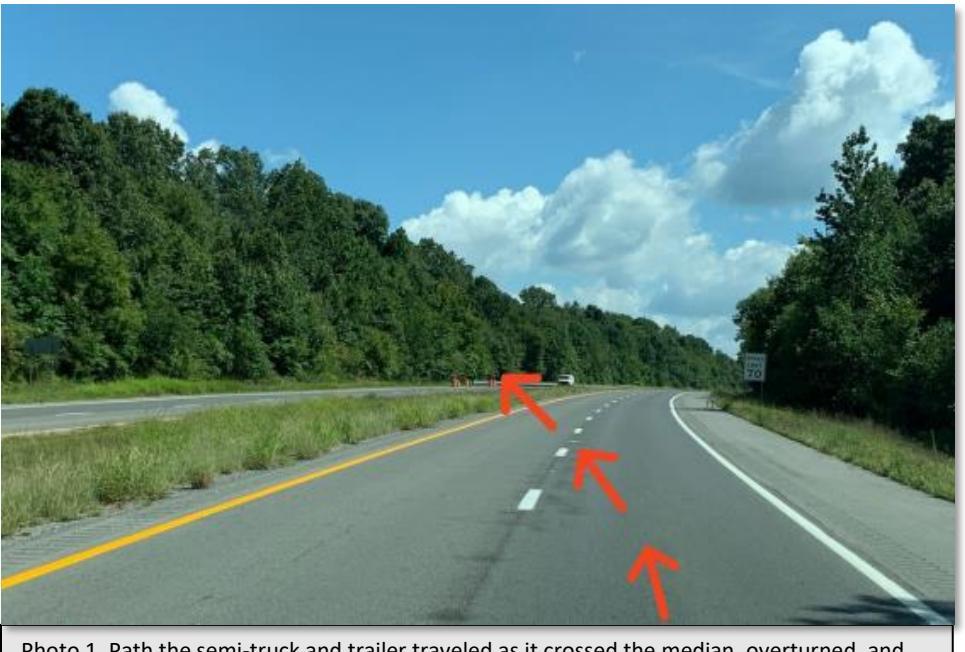
Photo 1. Path the semi-truck and trailer traveled as it crossed the median, overturned, and struck the W-beam guardrail. Photo property of KY FACE.

The incident initially began in the northbound lanes of a major, four-lane interstate. North- and south-bound traffic is separated by a grassy median that measures 31 feet across; no barrier was present in the median. The involved vehicle crossed the median, traveled across the southbound lanes, and struck a W-beam highway guardrail which was installed on the northbound right shoulder of the highway; the truck penetrated the guardrail, and came to final rest positioned partially off of the shoulder in a grassy area. The posted speed limit for this area is 70 miles per hour.

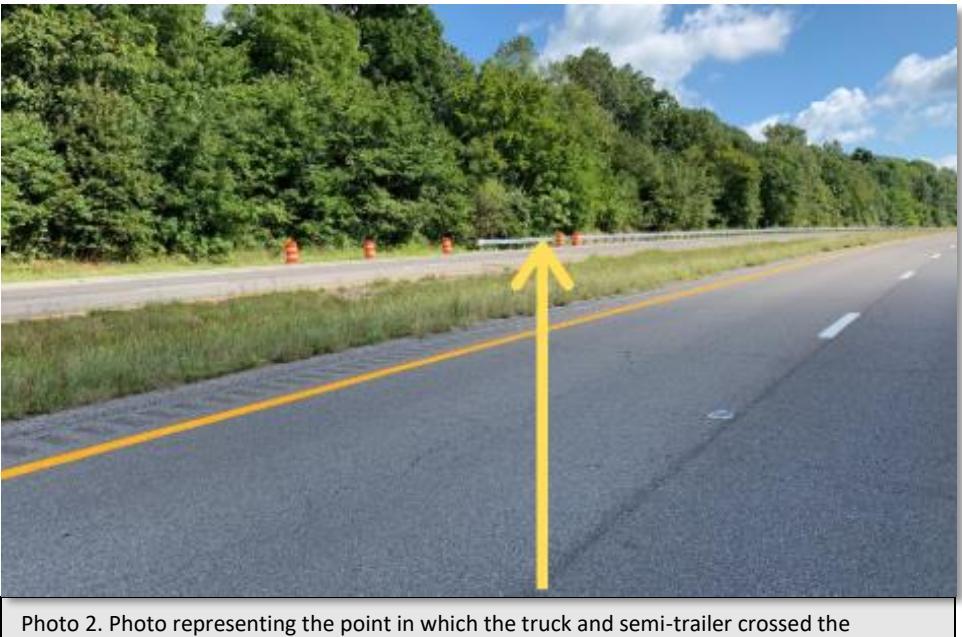
Photo 2. Photo representing the point in which the truck and semi-trailer crossed the median. Photo by and property of KY FACE.

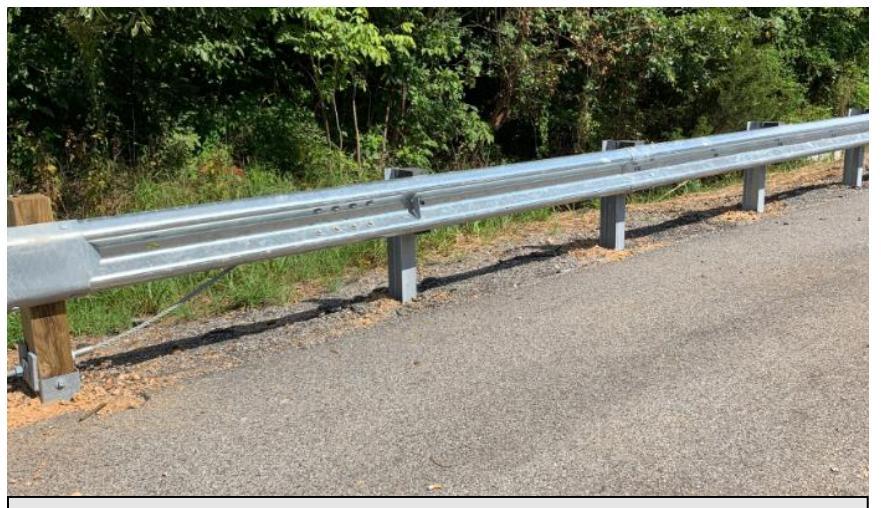
Photo 3. Photo of the area in which the truck struck the W-beam guardrail (final rest), the guardrail pictured above is the replacement section that was previously damaged in the crash. Photo property of KY FACE.

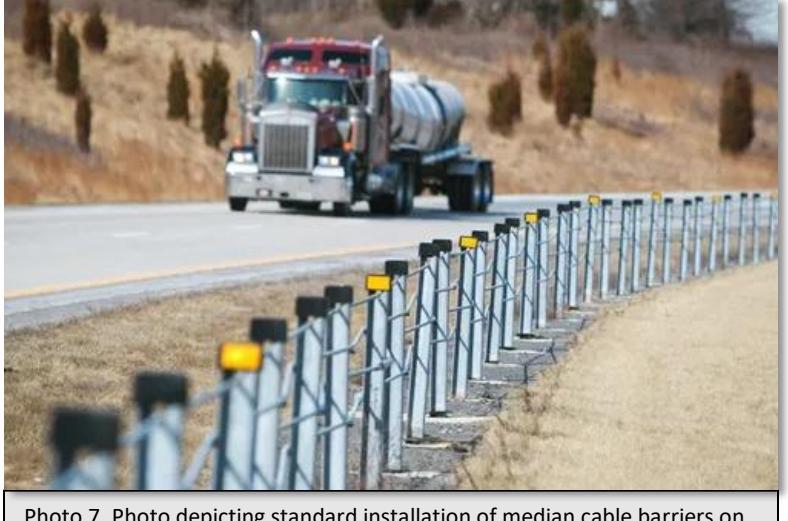
Photo 7. Photo depicting standard installation of median cable barriers on an interstate highway⁹.

Recommendation #5: Install Median Cable Barriers

Discussion: No type of median barrier was present at the scene; statistics prove that median cable barriers are an effective countermeasure in reducing the severity of collisions. According to a study conducted by the Michigan Department of Transportation (MDOT) in 2008, the installation of median cable barriers reduced cross-median collision by 87%. Furthermore, both severe injury and fatality collisions were decreased by 33% and rollover collisions reduced by 50% after the installation of median cable barriers⁸.

The Kentucky Transportation Cabinet should consider installing cable median barriers on all limited access highways and interstates to prevent median crossover collisions.
