EVENT TYPE: Grain Engulfment **REPORT#: 20KY006**

Farmworker Dies in Grain Bin Engulfment

Fatality Assessment and Control Evaluation (FACE) Program

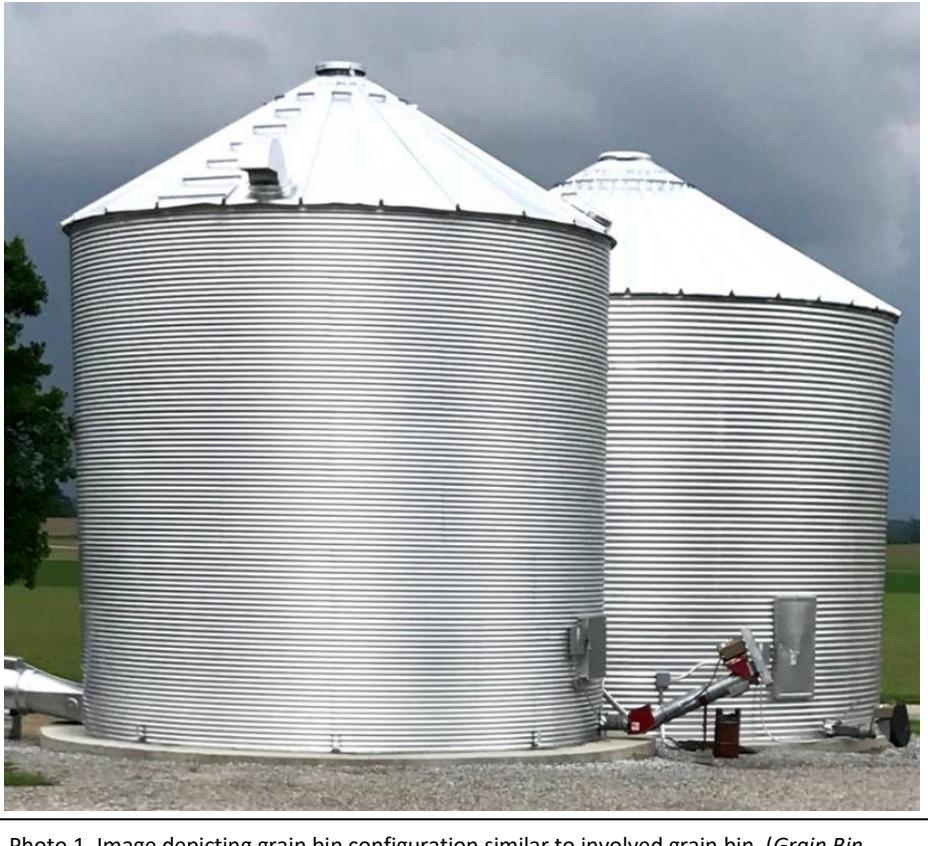
The incident occurred on the company's farm within a large grain bin. The capacity of the bin was 80,000 bushels - approximately 745,000 gallons. At the time the incident occurred, the bin contained approximately 60,000 bushels of corn. The grain bin was equipped with a center, bottom-mounted auger at the base of the bin in the center position.

Photo 1. Image depicting grain bin configuration similar to involved grain bin. (*Grain Bin Photo*. (n.d.).

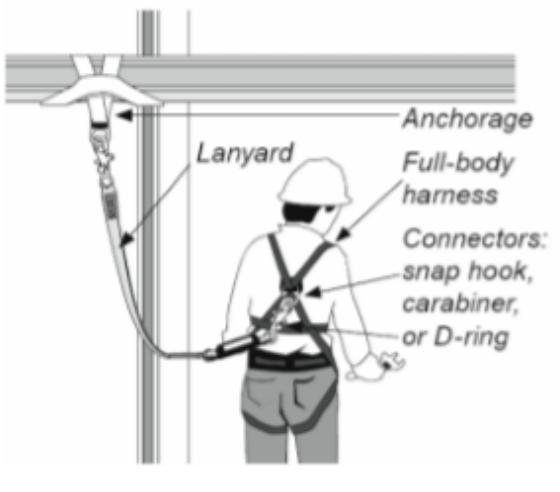
Use at least one of the following whenever workers are exposed to a fall of 6 feet or more above a lower level:

- Guardrails on ladders, roofs and platforms
- Safety Net Systems
- Fall Arrest Systems

A personal fall-arrest system

Diagram 2. Informative diagram showing proper guidance on fall protection for grain bin entry. (Grain Handling Safety Coalition, 2016)

Discussion: Although fall protection harnesses were available, the victim was not utilizing fall protection when the incident occurred. According to OSHA standard 1910.28(b)(1)(i), Employer must ensure that each employee on a walking-working surface with an unprotected side or edge that is 4 feet (1.2 m) or more above a lower level is protected from falling by one or more of the following: Guardrail systems; Safety net systems; or Personal fall protection systems, such as personal fall arrest, travel restraint, or positioning systems (OSHA, 2016).

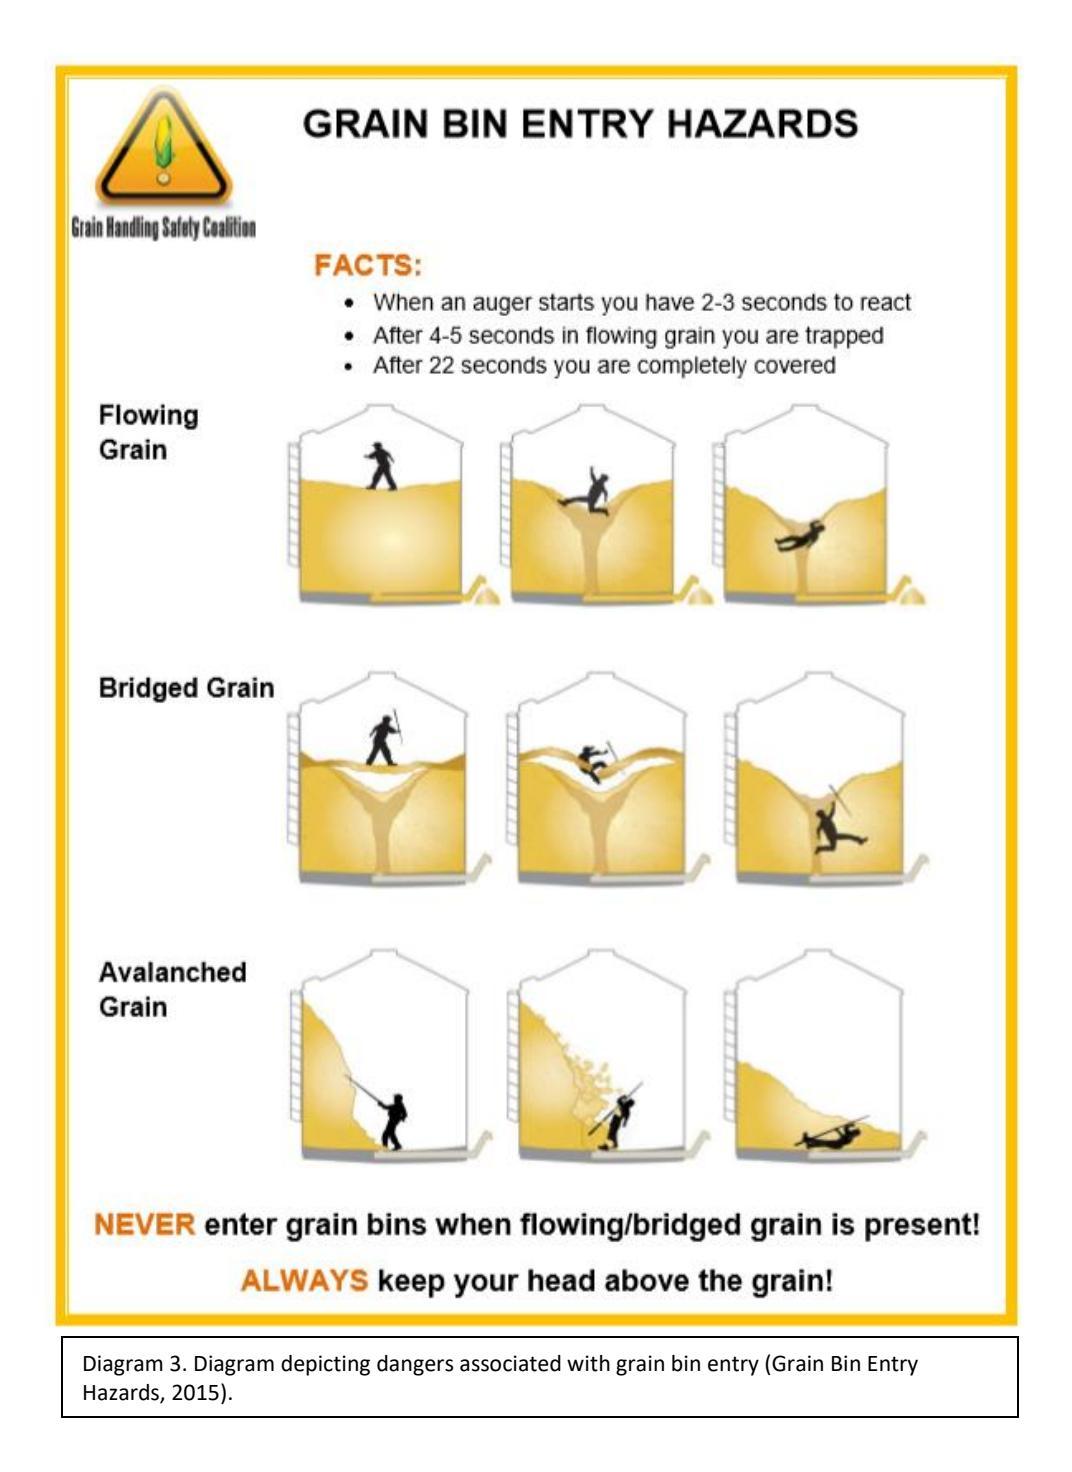
Employers should train their employees on the dangers associated with grain bin entry, many free training resources are available through the <u>Grain Handling Safety Coalition</u>. Resources available include videos, picture library, policy templets, posters and handouts like the one below:
