Fatality Assessment and Control Evaluation Project

KY FACE #97KY111

TO:	Carl Spurlock, PhD, Director, Kentucky Injury Prevention and Research Center, and Epidemiologist, Kentucky Department for Health Services
FROM:	Amy Scheerer, Field Investigator, Kentucky Fatality Assessment and Control Evaluation (KY FACE) Project
SUBJECT:	Construction Worker Dies in 7-foot Fall

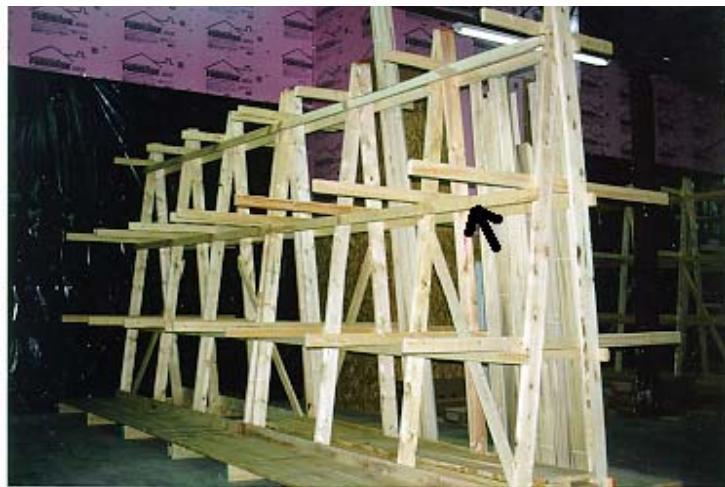
The wooden racks that the victim was hired to build in the warehouse are shown in Figure 1. The racks, made of mostly of 2"x 4" boards, stood 10 1/2 feet high and 12 feet long. They were made in an "A" shape with boards extending out crosswise at 3 1/2 feet, 7 feet, and 10 1/2 feet, to divide the rack into three evenly spaced sections on both sides. Long pieces of trim were to stand upright on the rack, resting on a 3-foot-wide base along the bottom. The warehouse was a large open area with a concrete floor. A doorway in the office area led directly into the warehouse. The victim was working on the eighth rack which still needed to have the base boards put along the bottom and the boards that extended out crosswise at the top of the rack. The victim did not wear any type of personal protective equipment (PPE) while working there and the business did not require him to do so.

wooden racks side-

fell [7 feet] is arrow).

Figure 1. Two by-side (height from which victim indicated by the

Recommendation #1: Employers should develop and enforce written policies related to safe work practices.

Recommendation #2: Employers should require the use of appropriate personal protective equipment (PPE).
