# Long Haul Trucker Dies After Striking an Embankment at the End of an Interstate Highway Off-Ramp

**Incident Number: 05KY074**

Incident Number: 05KY074 Release Date: May 2, 2007

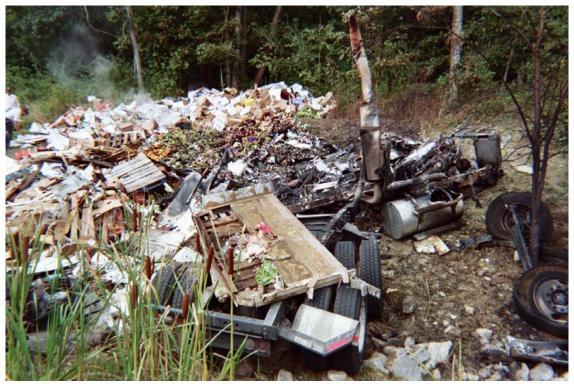
Picture of hillside with debris from semi-tractor trailer crash. (Photo courtesy of private company)

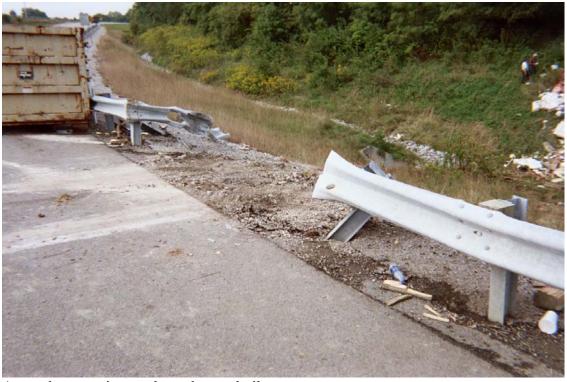
Area where semi went through guardrail.

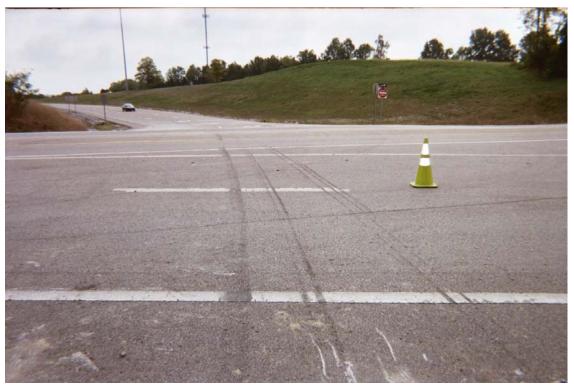
Skid marks on pavement caused by semi.
