Team Semi Driver Dies after Rig is Struck by Impaired Driver

Incident Number: 07KY091

Kentucky Fatality Assessment and Control Evaluation (FACE) Program
Incident Number: 07KY091
Release Date: February 17, 2010
Subject: Team Semi Driver Dies after Rig is Struck by Impaired Driver

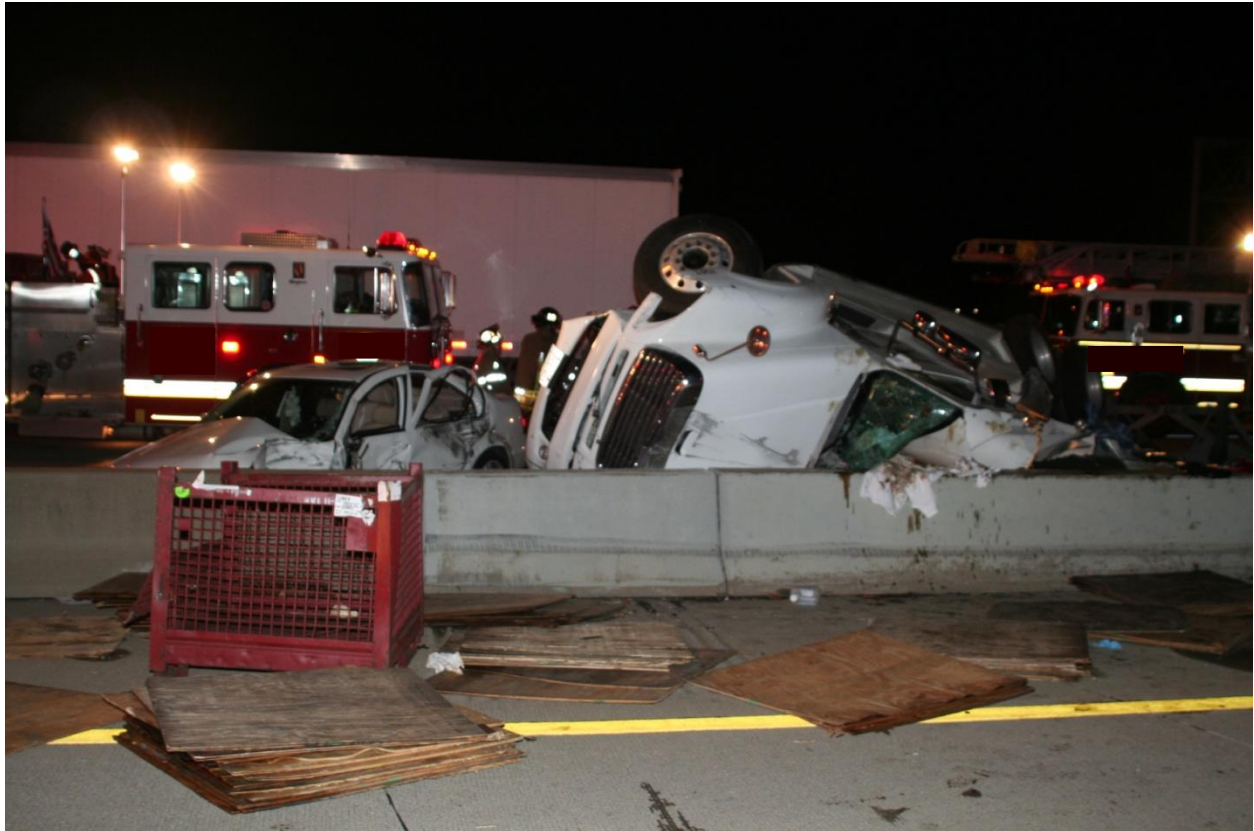
Photograph of semi and car involved in fatal crash. Photograph courtesy of law enforcement.

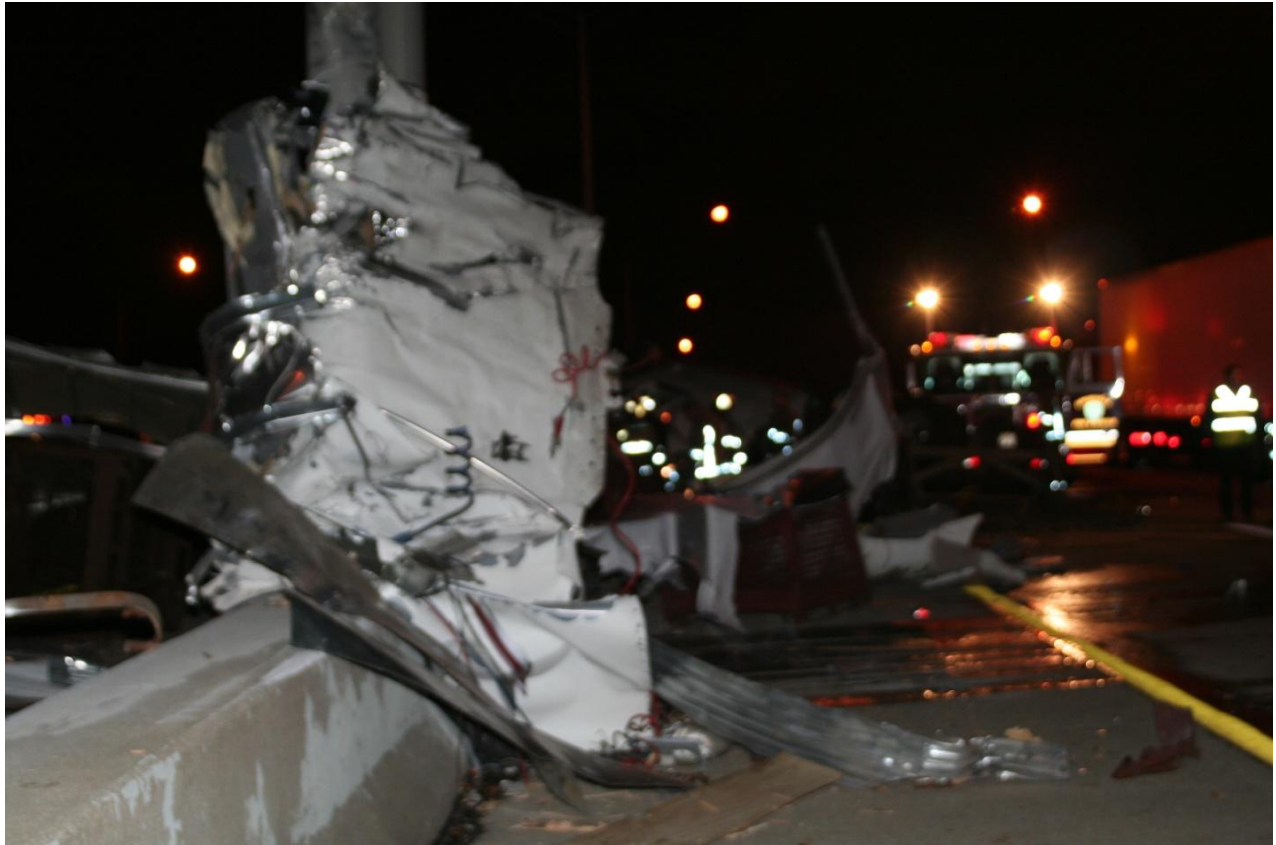
When the semi struck the wall, the trailer jackknifed, slid over and down the concrete barrier wall, and struck a sign post and breaking apart discharging the contents of the trailer onto the highway. The semi tractor rolled upside down in a barrel roll, slid along the pavement and down the side of the wall breaking apart. The passenger car, stuck in the right steering wheel, was pushed by the semi along the concrete barrier wall. The semi and the passenger car came to rest with the passenger car 20 feet in front of the semi. The bunk in the sleeper berth came loose and the husband was ejected from the semi. He was found on the pavement by the barrier wall under wire crates from the trailer. The semi driver was found buckled upside down in the driver's seat.

Photograph of trailer wrapped around sign pole. Photograph courtesy of law enforcement.

This incident occurred in a high traffic area where there was a 32 inch high concrete barrier wall to separate the two traffic directions. Trailer heights are usually 13 feet to 13.5 feet high. Concrete median barriers should be designed to prevent semis and trailers from flipping over the barrier. In this case, if the wall had been higher, the trailer could not have flipped over the wall, twisting the semi into a rollover.

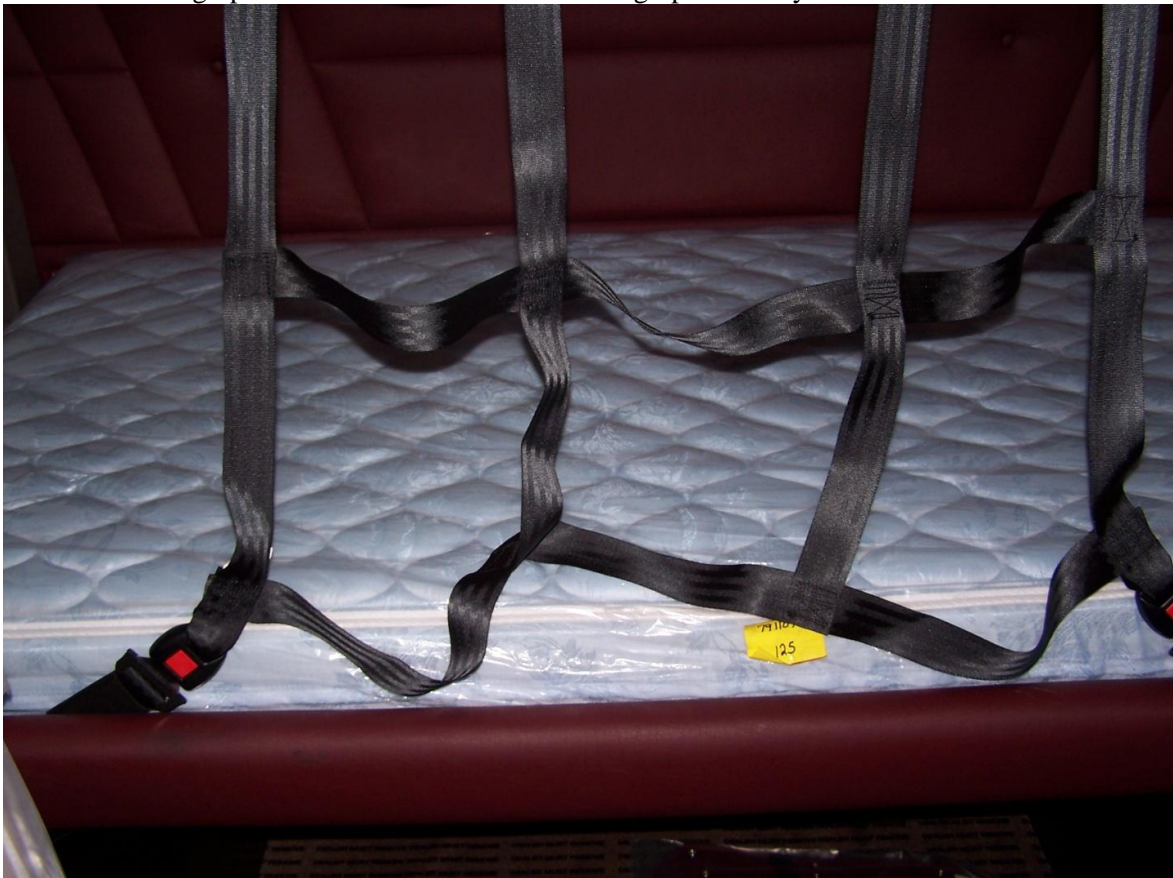
Sleeper berth occupant restraint systems manufactured by three different companies were evaluated for this report. All three manufacturers used a nylon webbing strap that snapped over the occupant in the sleeper berth. In two of the designs, the webbing strap created a triangle from the top of the sleep berth to the underside of the sleeper berth with the webbing as the hypotenuse. One design used the sleeper berth above to create a rectangle for the occupant to sleep in. Both designs allow for the occupant to be loosely restrained in the sleeper berth, thereby permitting movement of the occupant.

Photograph of a restraint system in a similar sleeper berth. Photograph by KY FACE.

It is unknown if the restraints for the sleeper berth were used at the time of this incident, or because of the severity of the crash, if a restraint system would have prevented the occupant from being ejected from the semi. The Federal Motor Carrier Safety Administration standard number 393.76 pertaining to sleeper berths states that semi tractors manufactured on/ after July 1, 1971 that are equipped with a sleeper berth must have an occupant restraint system. Currently, no standard requires the occupant of the sleeper berth to use the occupant restraint system.

Possible solutions to restrain occupants in sleeper berths might include the fabrication of a privacy curtain/restraint system in the sleeper berth, installing an air bag above the mattress that would deploy toward the occupant upon certain conditions, or the use of heavy foam within the sleeper berth to insulate from noise and protect the sleeping occupant.
