Foreign-born Semi Driver Dies After Driving Over Embankment

Incident Number: 09KY071

Kentucky Fatality Assessment and Control Evaluation (FACE) Program

Release Date: August 3, 2010

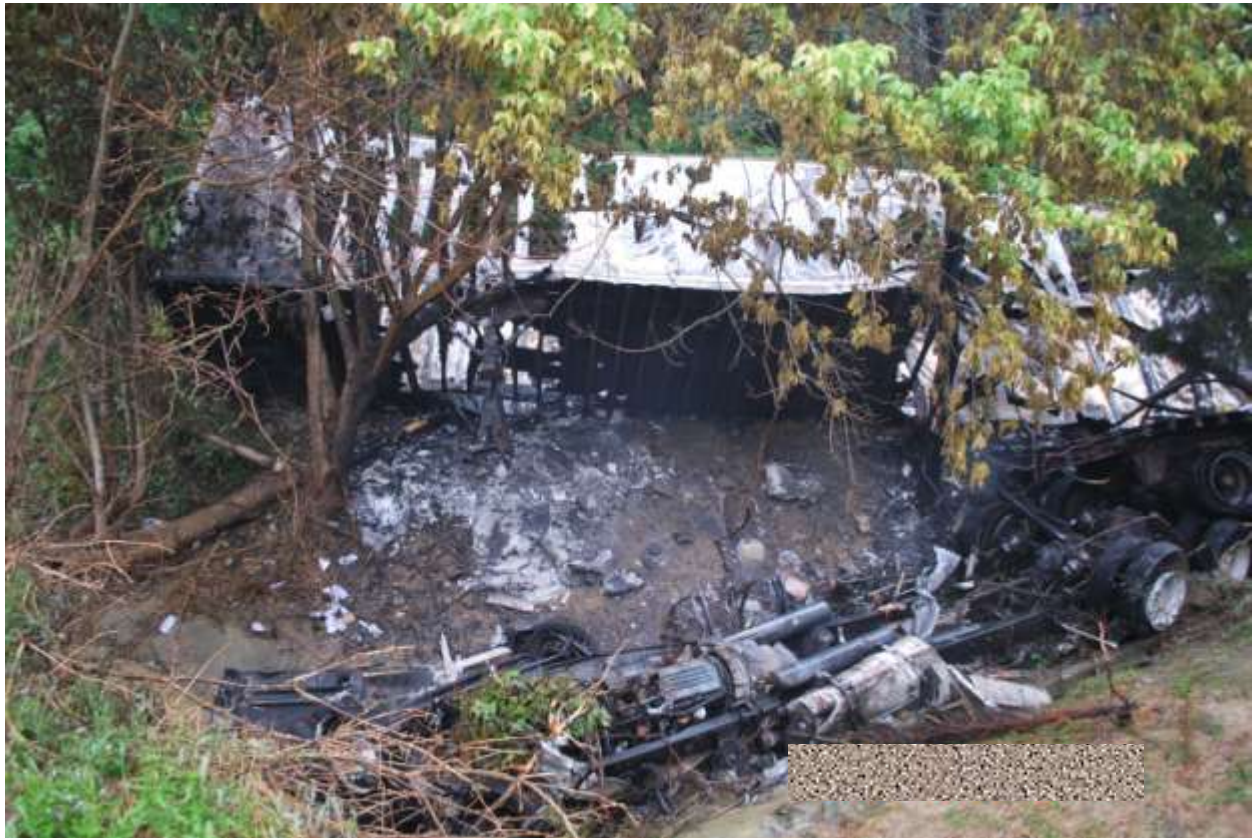
Photograph of the semi tractor-trailer involved in this incident. Photograph courtesy of local official.

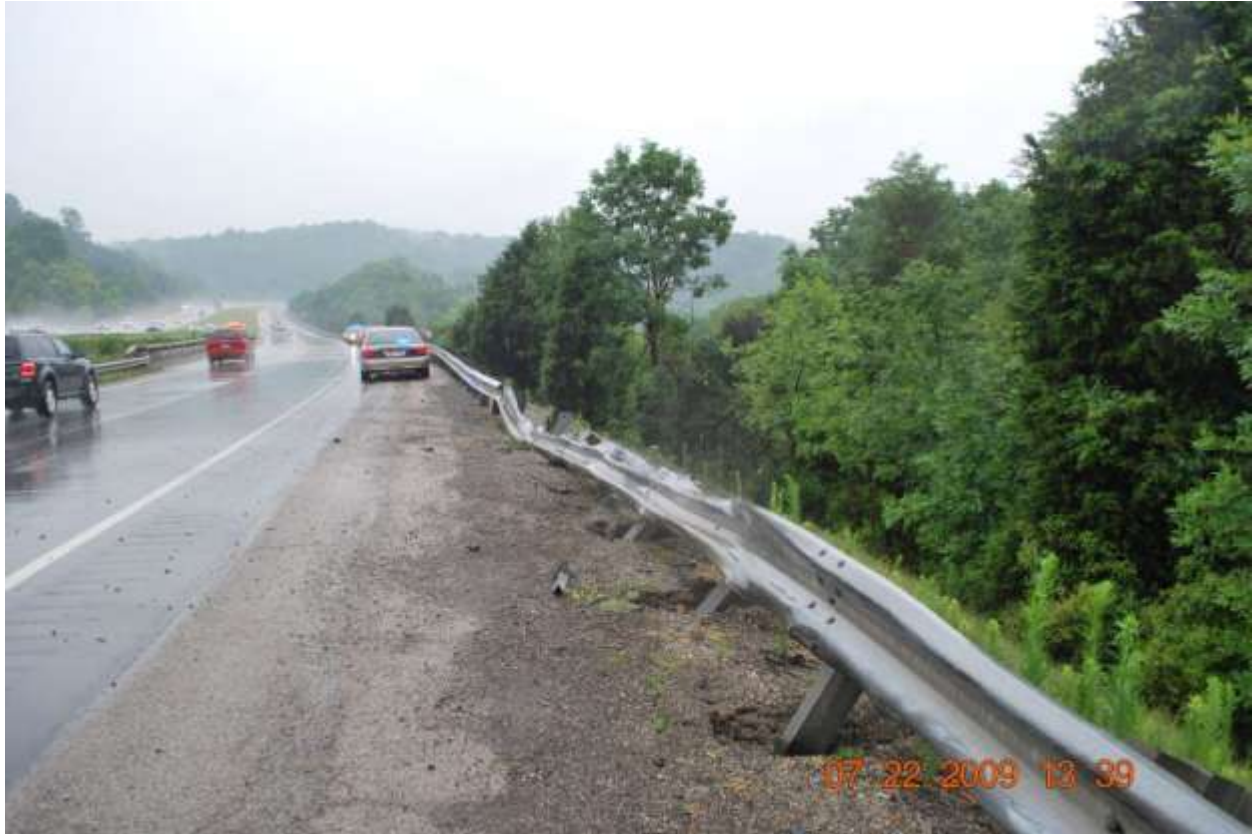
At approximately 11:30 AM, the truck driver had been enroute for approximately 50 miles and was headed southwest on a rural, four-lane interstate. It was raining, the asphalt pavement was wet, and the speed limit was 70 miles per hour. The local terrain was hilly, and the tractor-trailer was headed downhill into a curve when the driver drove off the pavement on the right side over the emergency lane, over a guardrail, then traveled 185 feet through dense trees and into a ravine. With the fuel tanks damaged, the tractor overturned and the trailer disengaged from the fifth-wheel. A fire ensued; the tractor flipped over, ejecting the driver and the tractor came to rest on its top. The trailer settled in an upright position partially across the overturned tractor.

Location where semi tractor-trailer driver drove off of interstate into ravine. Photograph courtesy of local official.

Recommendation No. 5: A comprehensive motor vehicle safety assessment of Kentucky’s interstate system needs to be performed in the area where the collision took place.

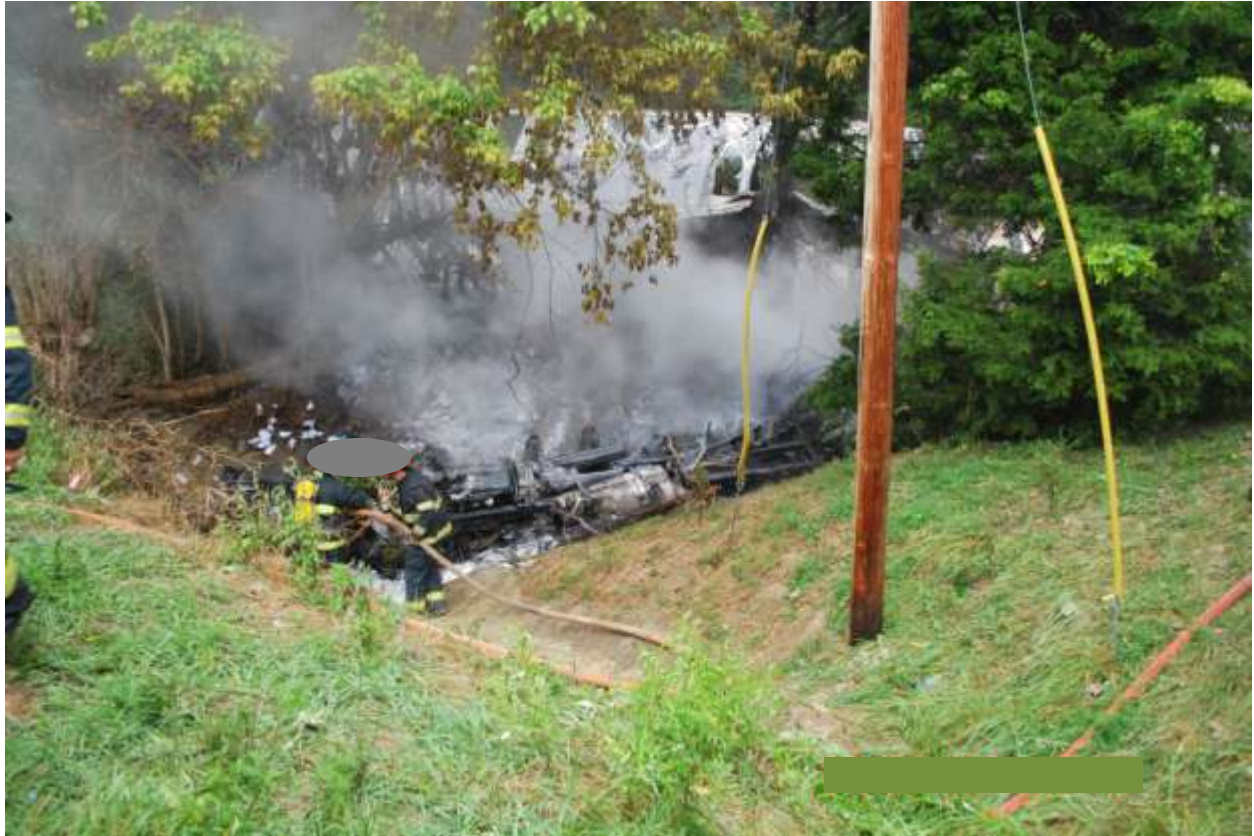
Path of semi tractor-trailer from the interstate. Photograph courtesy of local official.
