### Two Tree Trimmers Die When Struck By Errant Semi Tractor-Trailer

**Incident Number: 10KY009**

Incident Number: 10KY009

Release Date: October 27, 2011

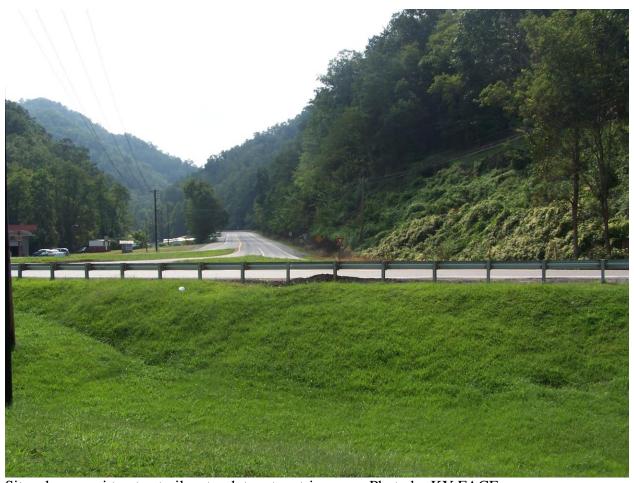
Site where semi tractor-trailer struck two tree trimmers. Photo by KY FACE.

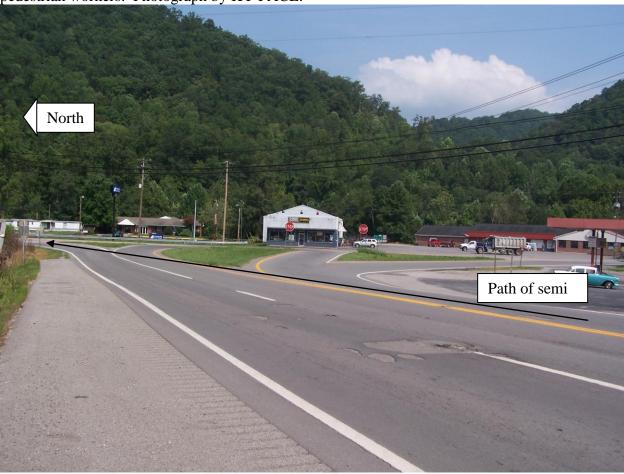
Photograph 1: Federal and state highway intersection where a semi tractor-trailer struck two

pedestrian workers. Photograph by KY FACE.

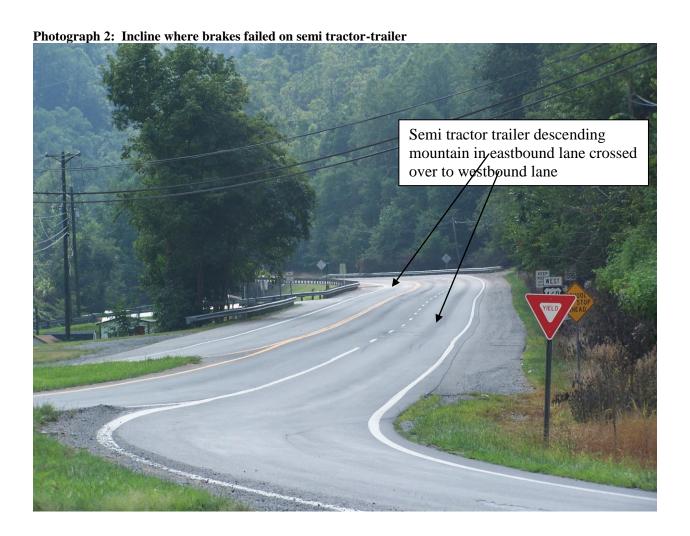
View of intersection coming down the mountain; semi drove to the left
