# **Truck Driver Dies When Tractor-Trailer Leaves The Road And Plunges Into A Creek-Bed**

**Incident Number: 13KY039**

**Kentucky Fatality Assessment and Control Evaluation (FACE) Program**  
**Incident Number: 13KY039**  
**Release Date: November 20, 2013**  
**Subject: Truck Driver Dies When Tractor-Trailer Leaves The Road And Plunges Into A Creek-Bed**

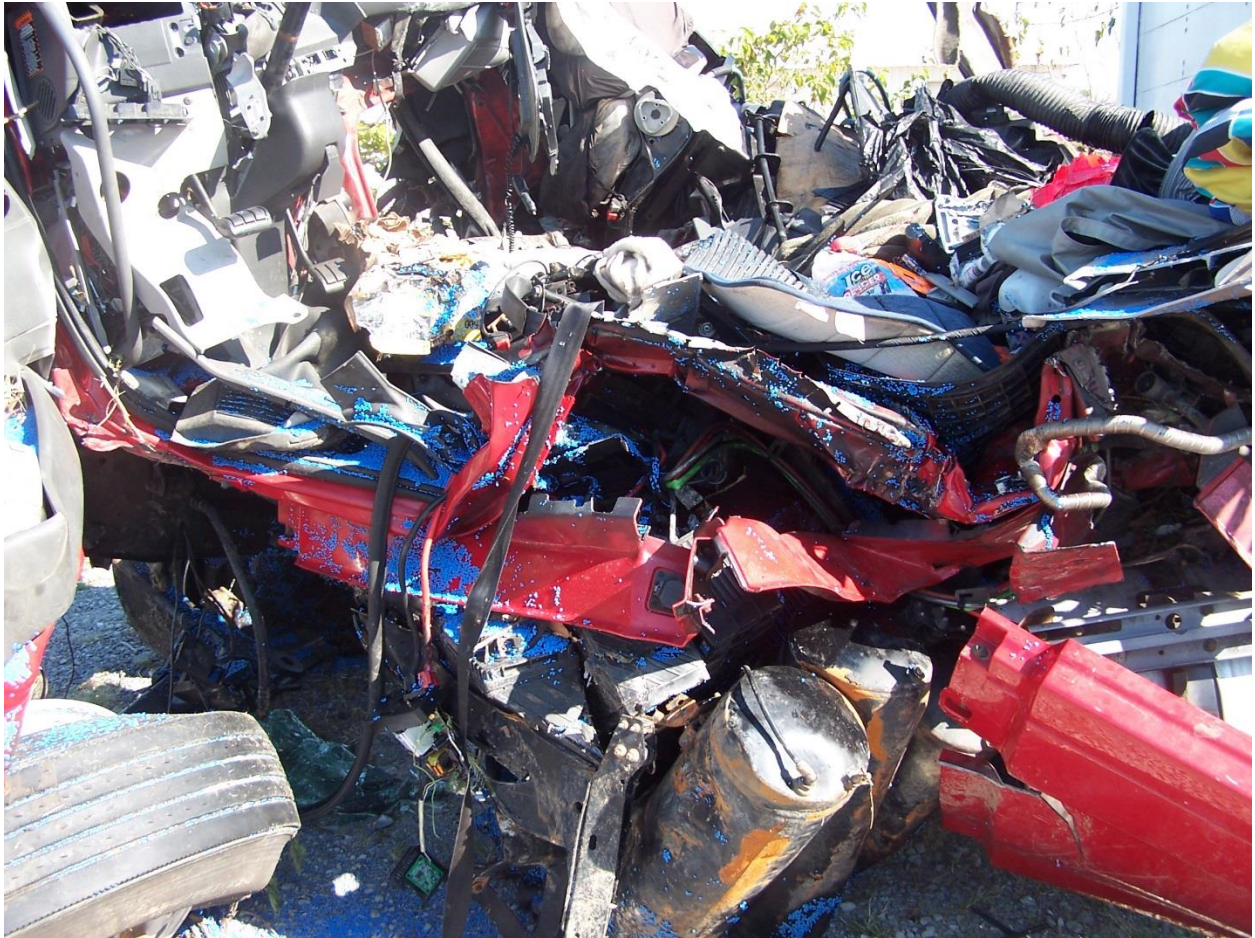
**The Tractor involved in the crash. Photograph property of KY FACE program**

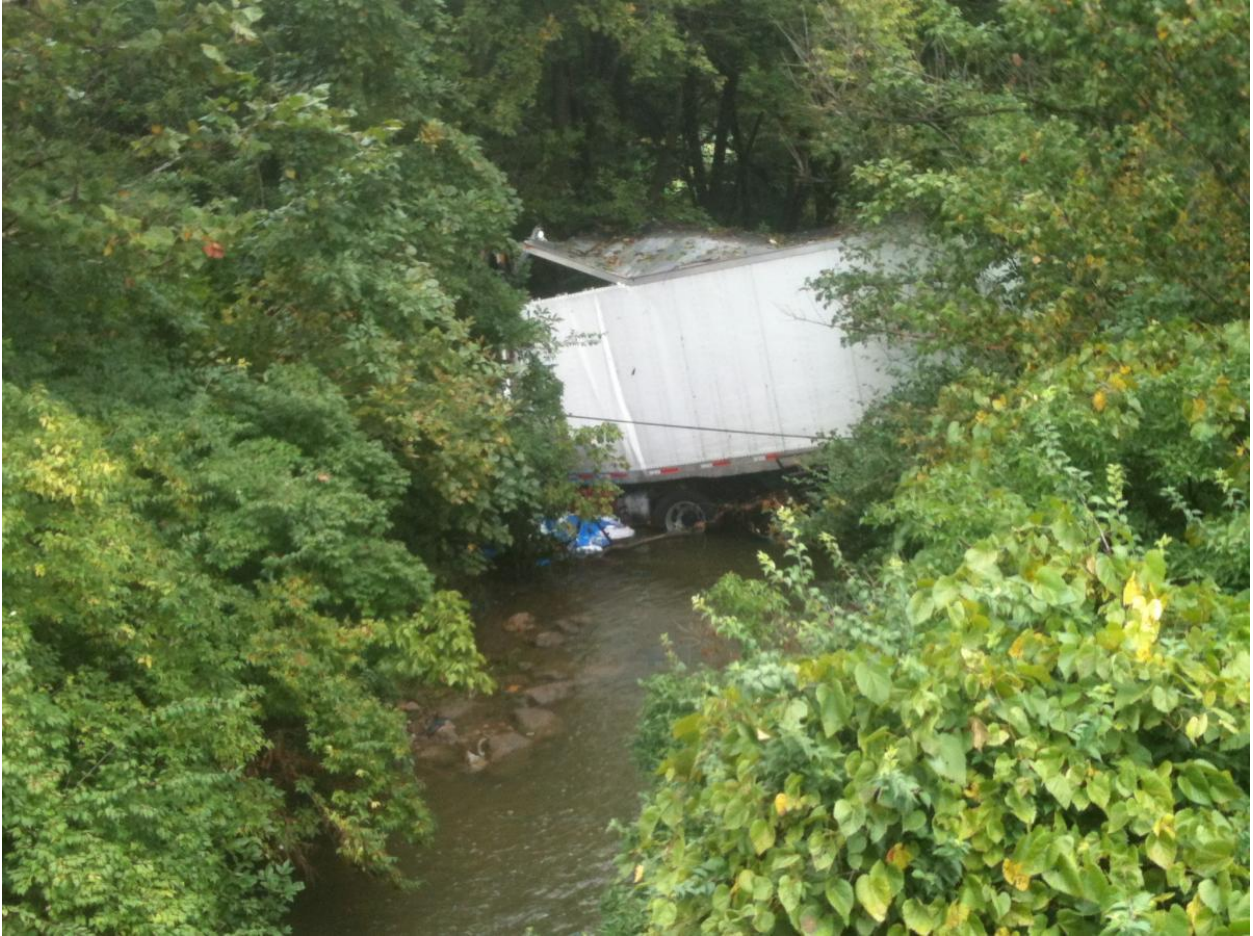
The tractor trailer exited the roadway on the right side of the interstate, traveled down a culvert and through a wire fence taking down trees before nosediving into a creek. From where the semi-truck left the interstate, it was approximately 1,320 feet to the creek bed. There were no skid marks or brake marks on the pavement prior to leaving the interstate lane. The force of the collision caused the fifth wheel to rip away from the tractor but remained on the trailer as the trailer came up over the cab. The driver became trapped in the semi-tractor. There were no other motorists who witnessed the crash.

The creek where the truck landed after crashing. Picture courtesy of WLEX 18 News.
