Semi Truck Driver Falls Asleep While Driving, Crashes and Dies

Incident Number: 11KY009

Kentucky Fatality Assessment and Control Evaluation (FACE) Program

Subject: Semi Truck Driver Falls Asleep While Driving, Crashes and Dies

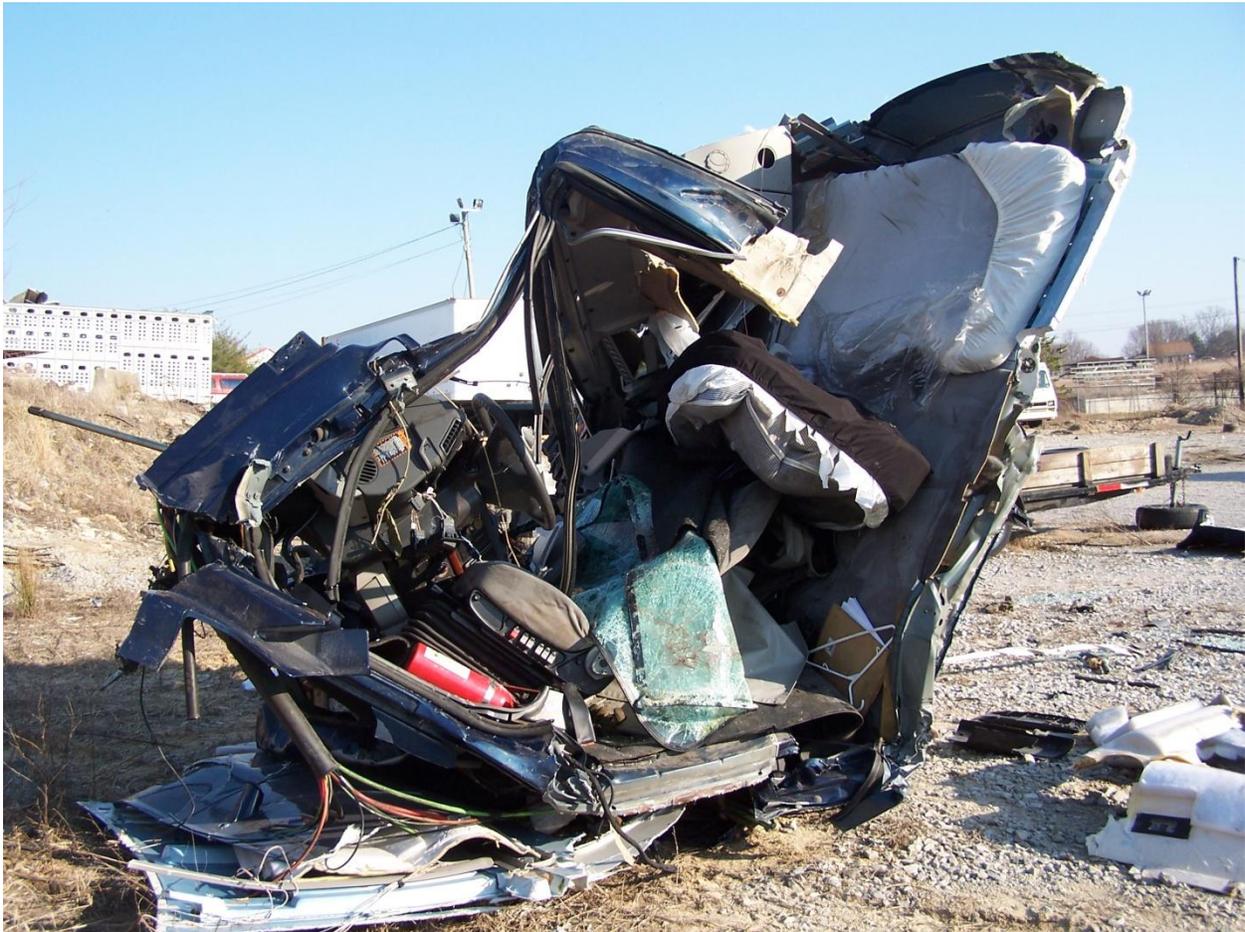
Photograph of tractor involved in crash. Photograph property of KY FACE.

Extracting the driver from the wreckage was complicated due to the load of tomatoes that had impacted the back of the tractor from the trailer. Upon impact, the cab separated from its chassis. The driver was wearing his seatbelt and the airbag deployed upon impact. Neither speed nor alcohol were suspected as contributing factors in the crash.

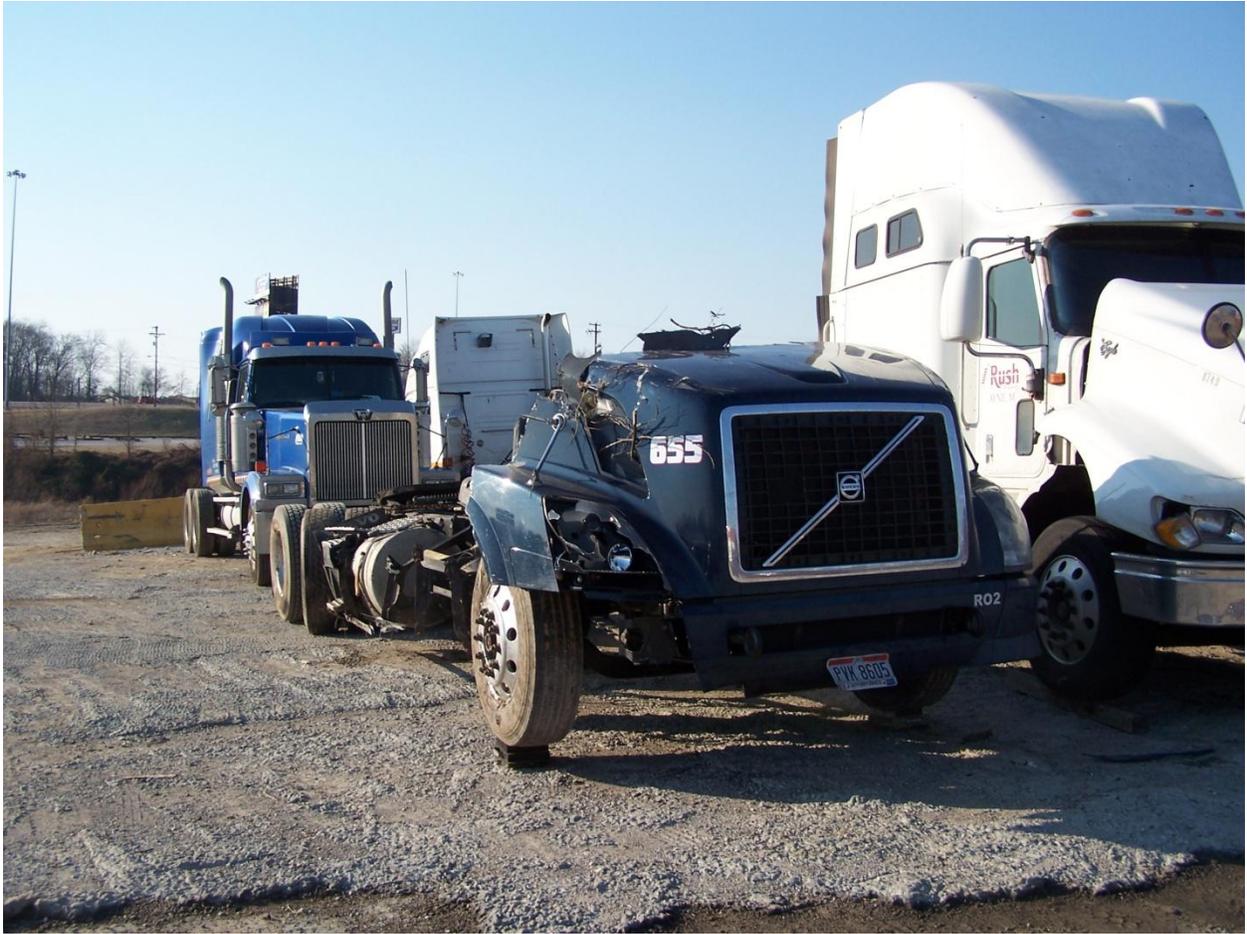
Front section of semi. Photograph property of KY FACE

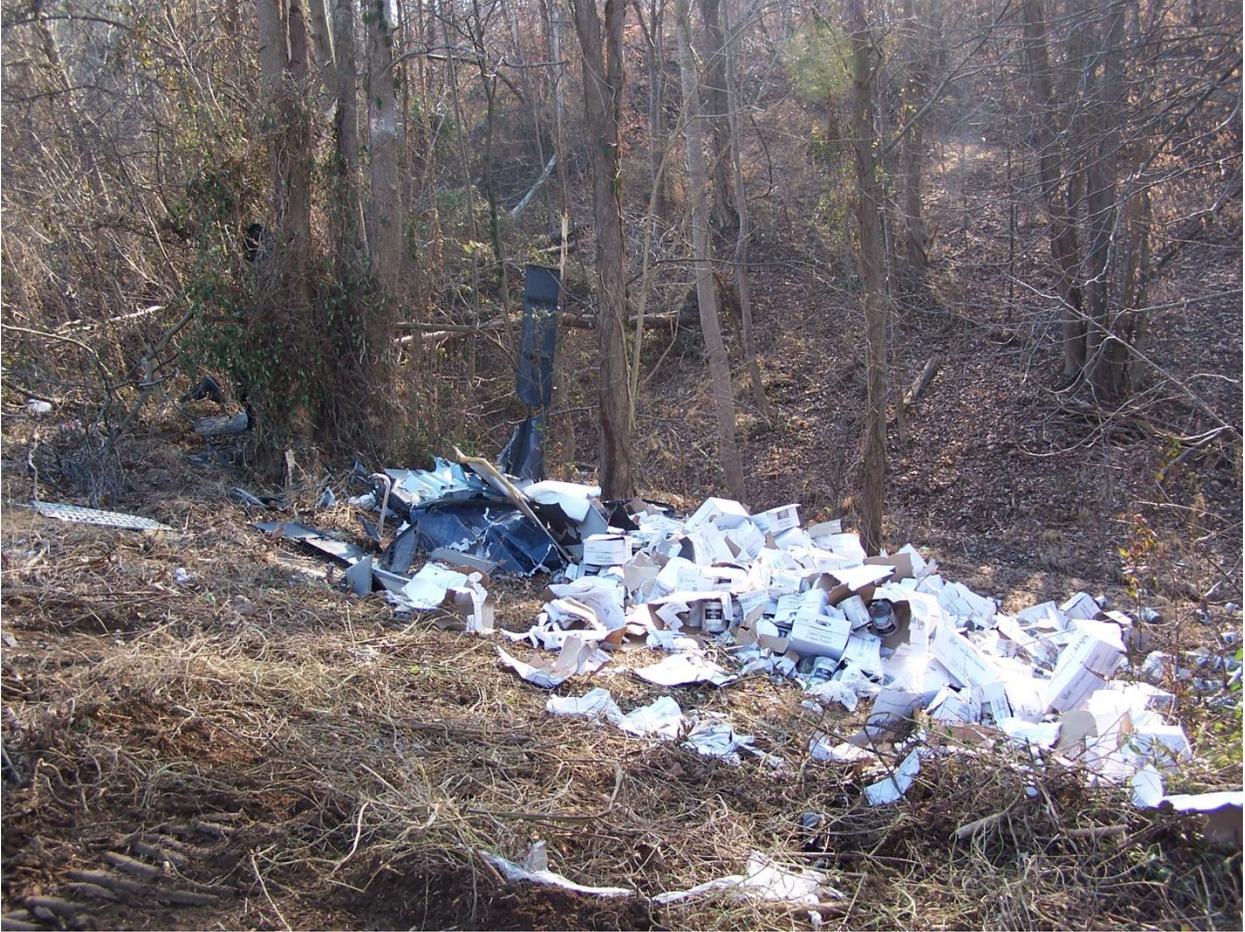
Load of canned tomatoes ejected from semi. Photograph property of KY FACE.

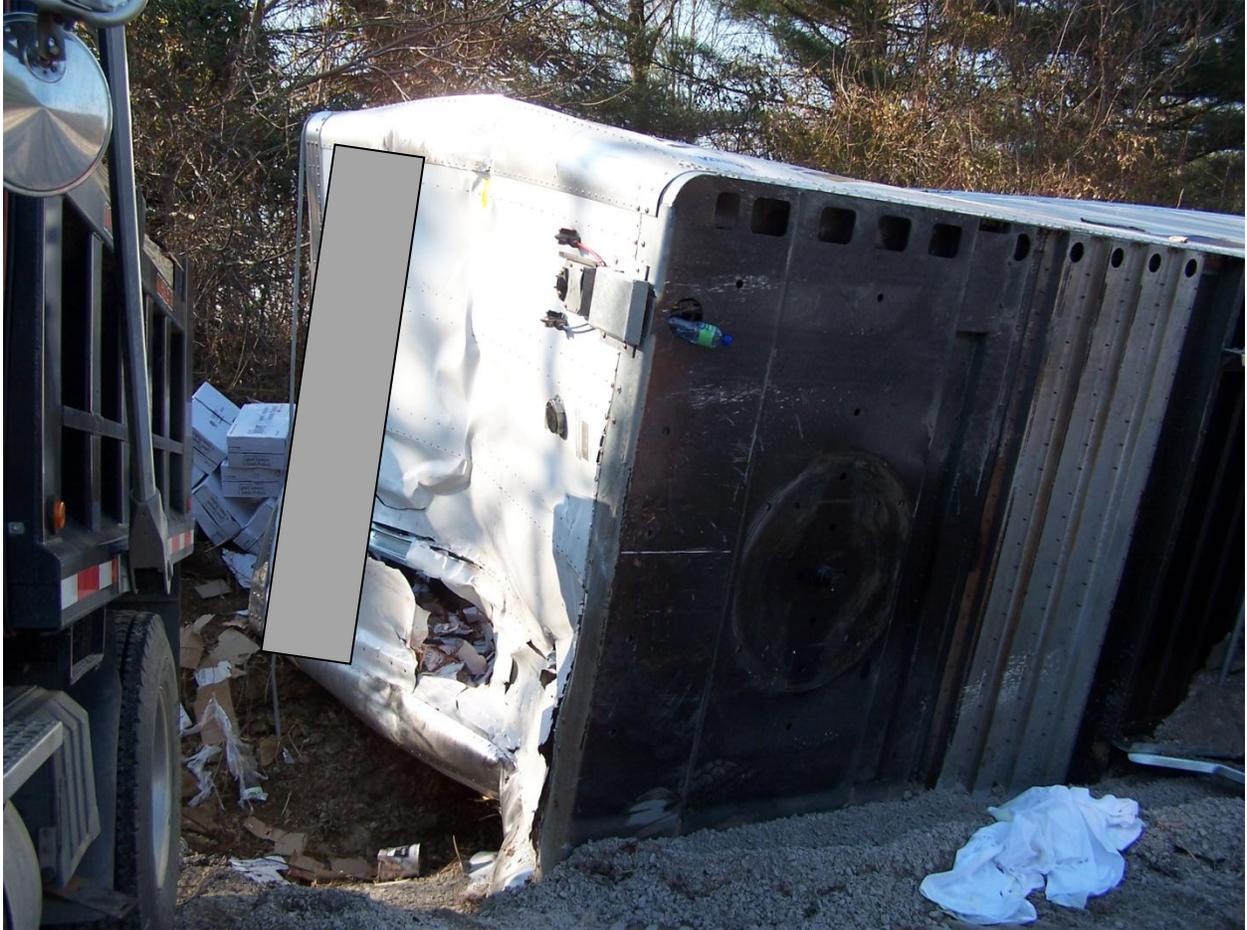
Trailer involved in crash. Load was ejected out of the top and into the cab. Photograph property of KY FACE.
